*Technical Service
Information Bulletin
February 12, 2015*

**Subject:
Corrective actions to take
if the stop light switch plunger
doesn't reach the brake arm**

TSIB number 150

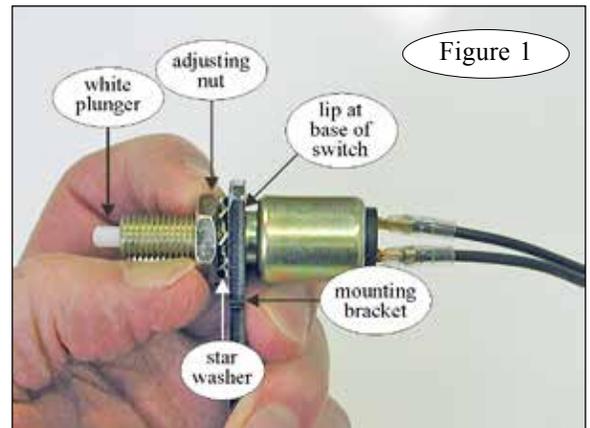
While our stop light switches fit the overwhelming majority of vehicles as is, the possibility exists that a switch may not have enough reach for the white plunger (at the end of the switch) to be completely depressed against the brake arm. This is necessary for the switch to operate properly.

The stop light switch comes with two nuts which are used to adjust the switch forward and backward. But if the plunger won't reach the brake pedal arm, remove one of the nuts. Leaving the star washer (Figure 1) in place, position the stop light switch mounting bracket against the base of the switch (Figure 1).

1. First, remove one of the adjusting nuts.

This will lengthen the reach of the switch by about 3/16".
