Technical Service Information Bulletin 7/8/2025

Subject: BAL Equalizer Hanger Incompatibility With Comfort Ride Suspension Installation

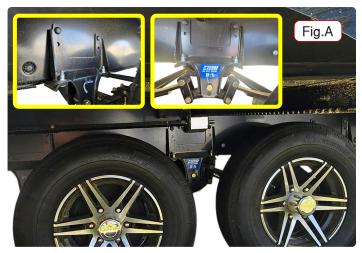
Offset Mounting Hangers – These are offset to one side of the frame rail (Fig.A).

- Removal Difficulty: These hangers are riveted to the inside and outside of the box frame, making

removal difficult. Grinding may be required, and not all installers may be equipped or willing to perform this operation. Some customers may not want such extreme modifications, as well.

- **Mounting Interference:** The Comfort Ride slipper box cannot mount correctly without complete removal of the factory BAL hanger. Additionally, if the hanger is offset, the installer *must fabricate a custom mounting platform to realign the spring box and retain correct axle tracking.*

- **Pre-Screen Units:** Before scheduling an installation, ask the customer to take a clear photo of the spring hanger area and submit it to the service department. This prevents the customer from making an unnecessary trip only to find the installation cannot proceed.
- **Evaluate Capability:** Each installer should assess whether they have the tools and expertise to remove the factory BAL hangers and fabricate a custom mounting solution, if needed.
- **Communicate Clearly:** Let the customer know this is a non-standard installation that may require additional labor, fabrication, or parts, and may not be feasible for all shops.
